Soldiers' & Sailors' Memorial: Conditions Survey & Restoration Treatment Study

Final Presentation – Community Board

22 February 2017

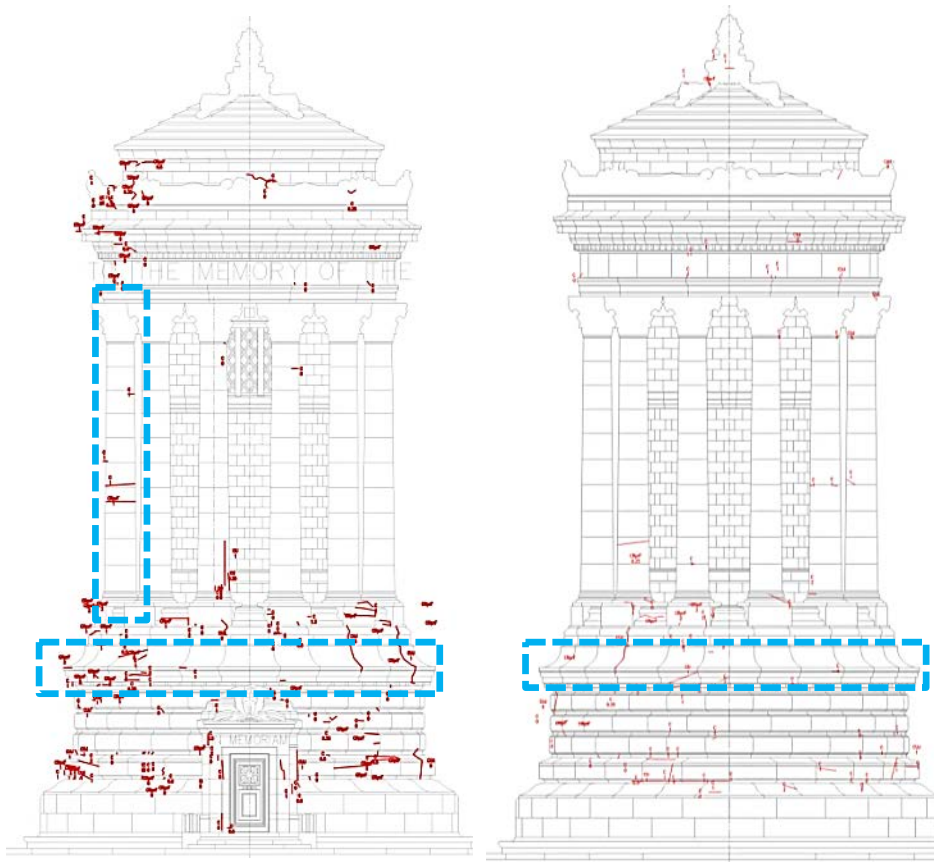
Monument Exterior:

~ Findings: Cracks

~ Recommendations: Crack filler, pinning, Dutchman repairs

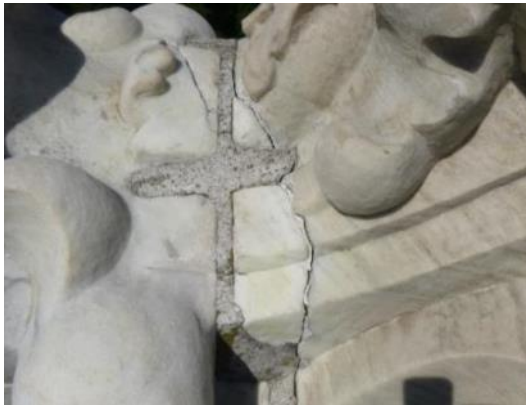
Finial and Consoles

~ Finding: Spalls, failed patches, and fissures

~ Recommendation: Dutchman, patch and crack filler

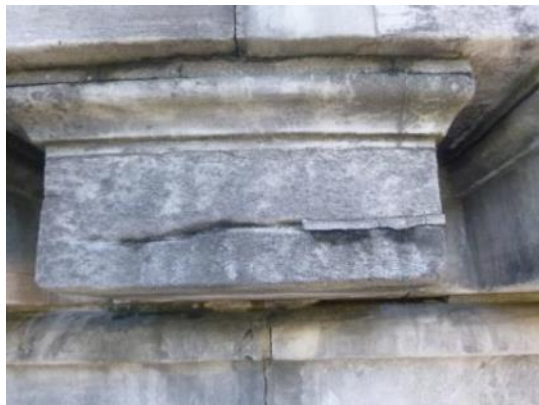
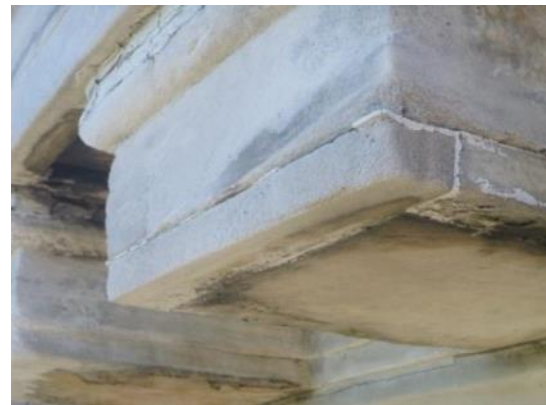
Upper and Lower Modillions

~ Findings: Failed Dutchman, crack repairs and ACM in sealant, typ., fissures, and spalls

~ Recommendations: New Dutchman, consolidation, sealant abatement

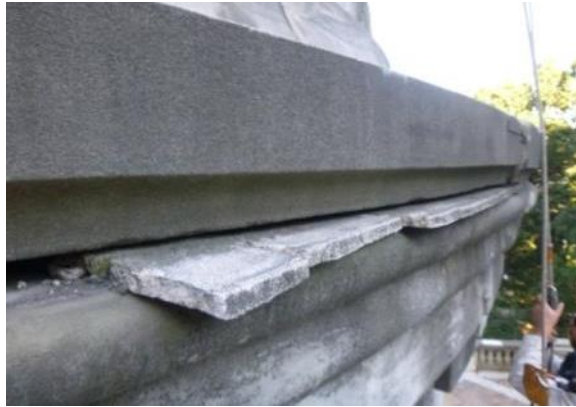
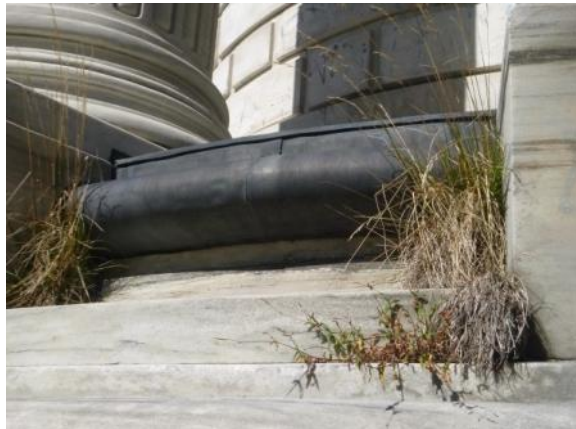
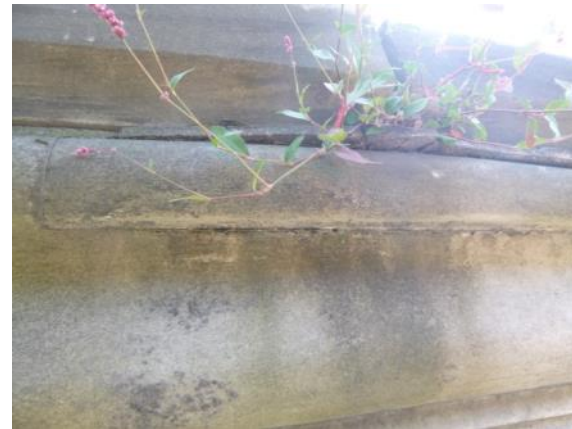
- ~ Findings: Deteriorated mortar, biological growth and open joints
- ~ Recommendations: 100% Repointing

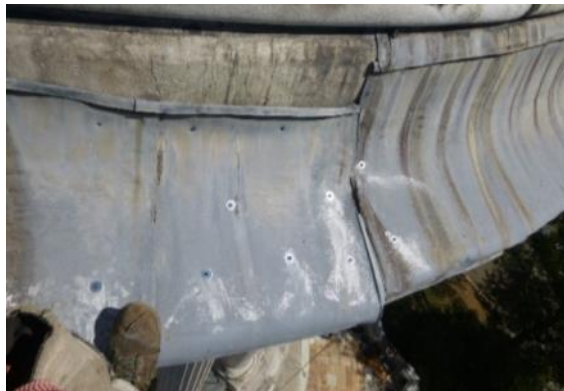
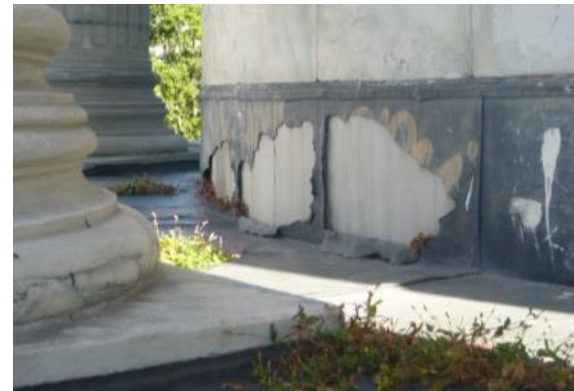
Monument Exterior – Sheet Metal Roofing

~ Findings: Main Roof, Gutter Infill, Cornice – repairable

Base of Drum – excessive tears and holes

~ Recommendations: Repair Main Roof, Gutter Infill, Cornice;

Replace lower drum roof with liquid-applied membrane

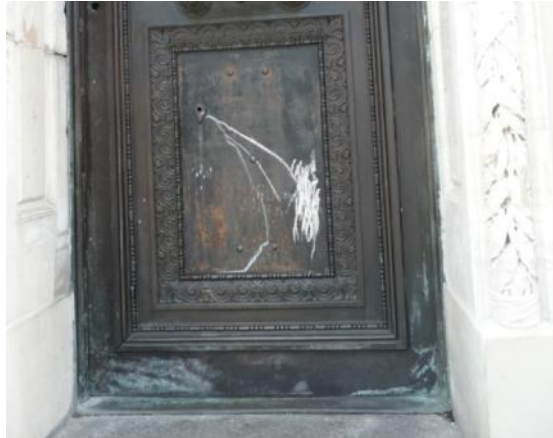
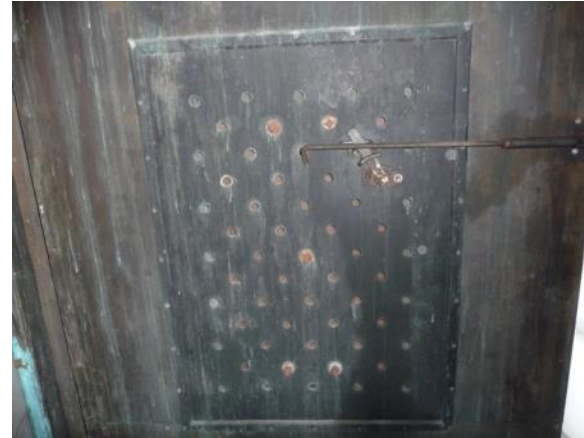
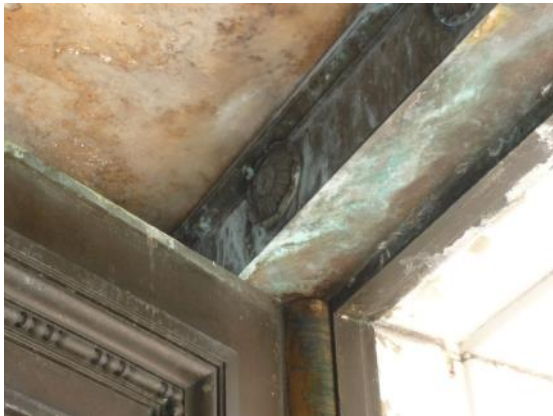
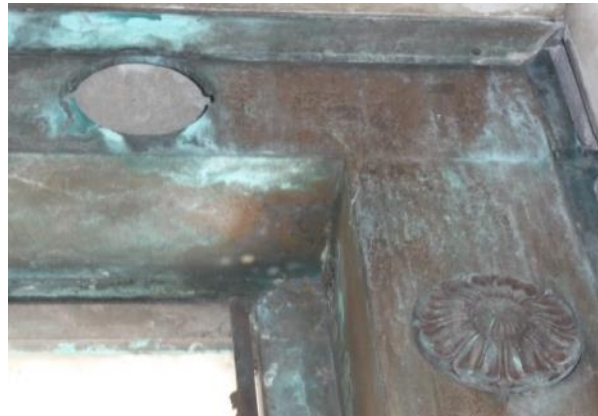
Monument Bronze Door

- ~ Findings: Severe deterioration and inoperable condition
- ~ Recommendations: Refurbish in off-site facility and reinstall

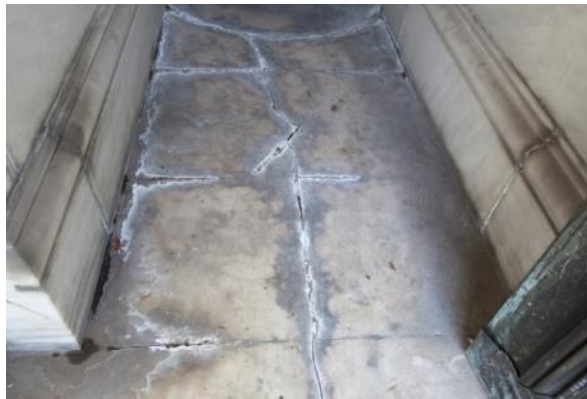
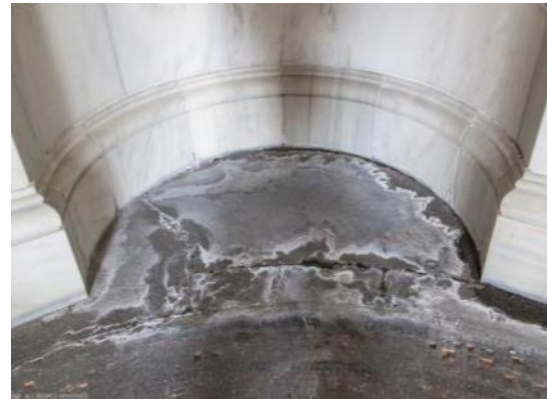
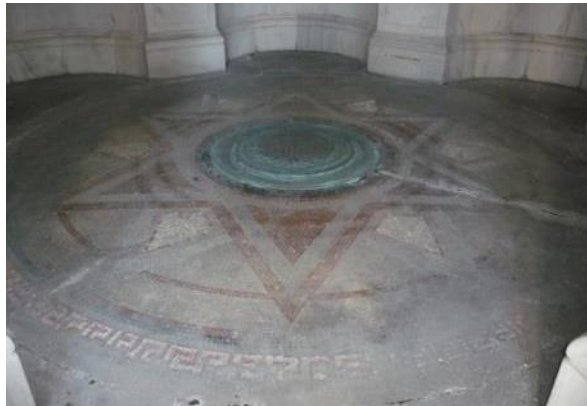
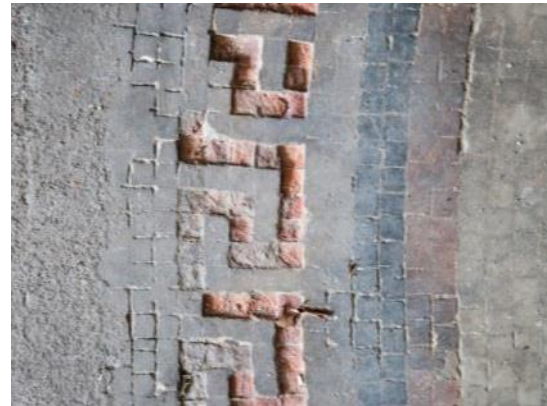
Monument Interior: Marble and Mosaic Floor

- ~ Findings: Cracked marble, missing and eroded tesserae
- ~ Recommendations: Crack repair and replace missing tesserae; repair concrete slab at manhole cover; clean and repatinated bronze

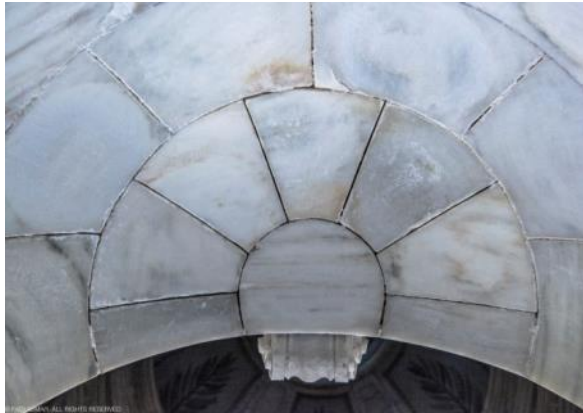
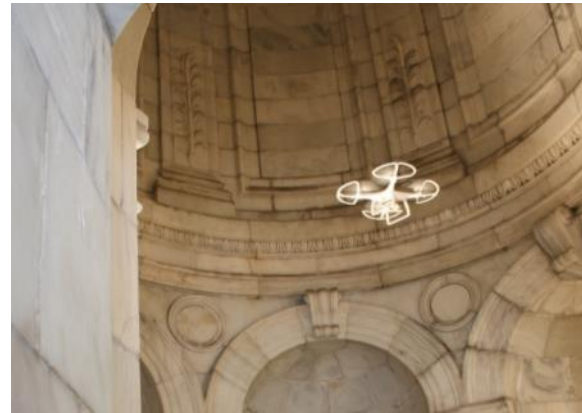
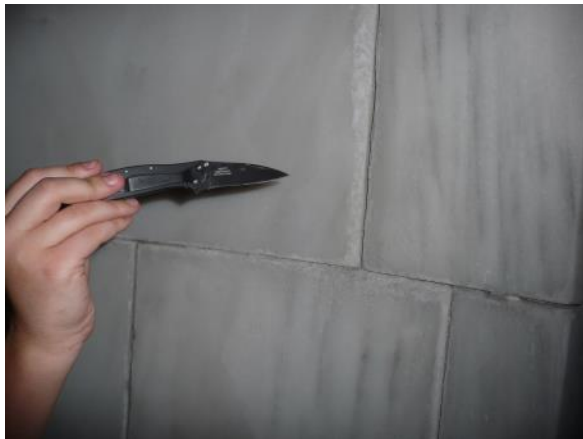
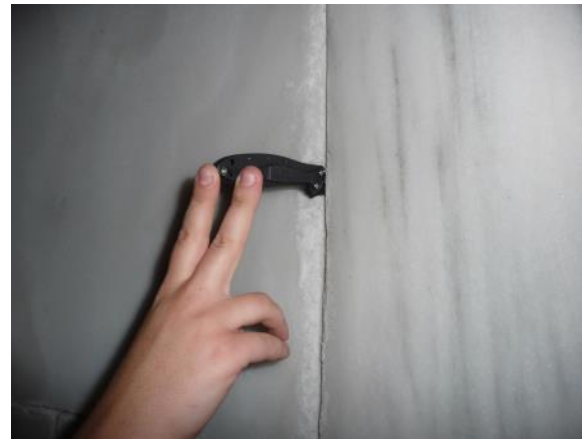
Monument Interior via Drone Survey

- ~ Findings: Open Joints and efflorescence, typ., selected spalls
- ~ Recommendations: 100% repointing, Dutchman repairs

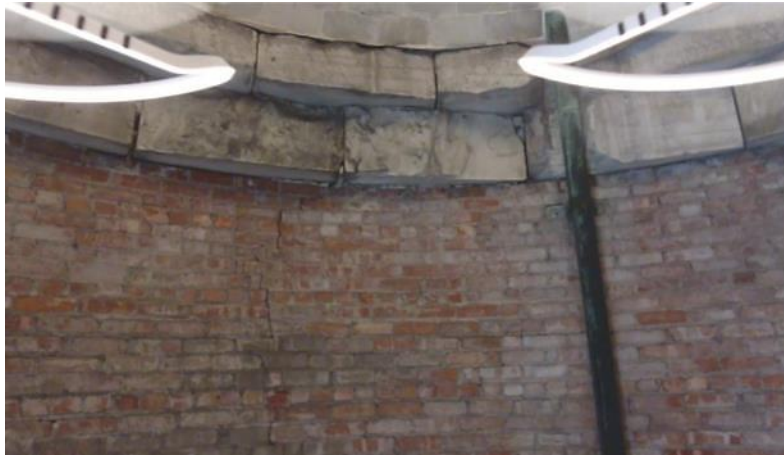
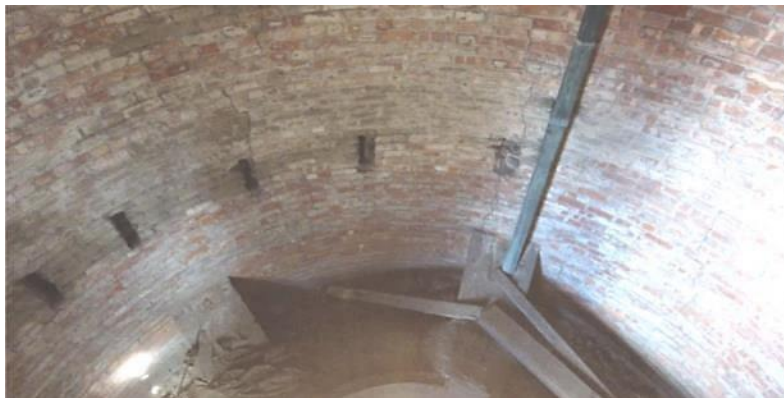
Monument Interior: Brickwork between Oculus and Guastavino Vault

- ~ Findings: Open joints and vertical cracks
- ~ Recommendations: 100% repointing and selective brick stitching

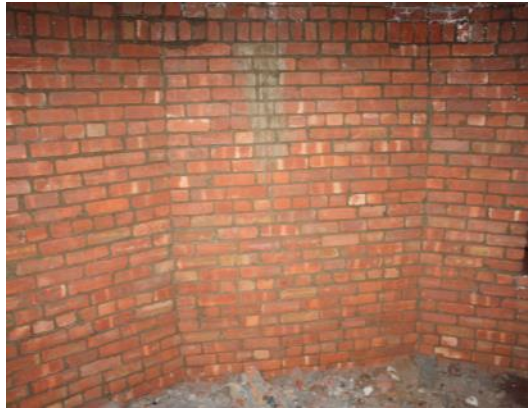
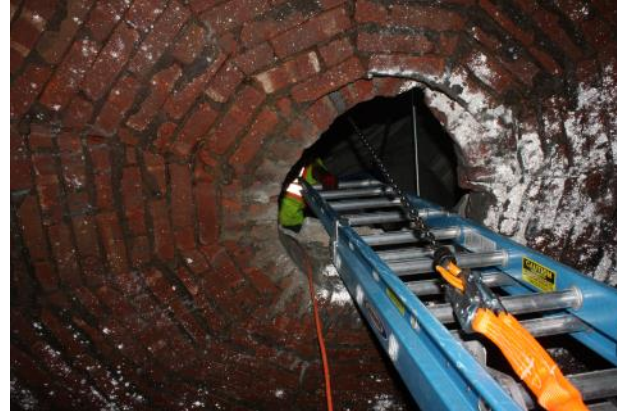
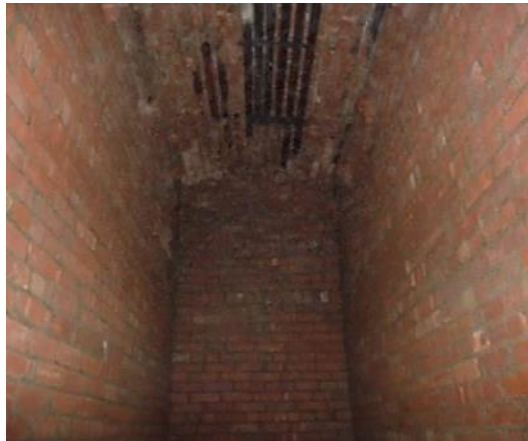
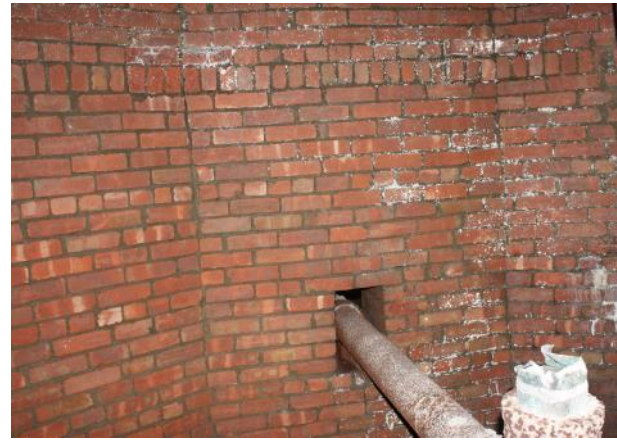
Monument Interior – Brick Vault and Adjacent Brick Chamber

~ Findings: Overall good condition with excessive moisture

~ Recommendations: Repair concrete slab at manhole cover

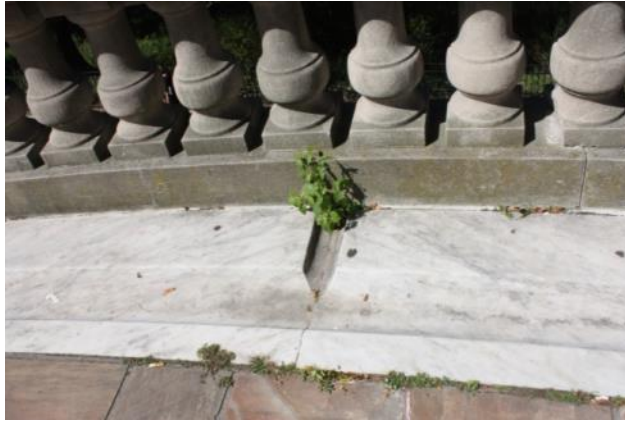
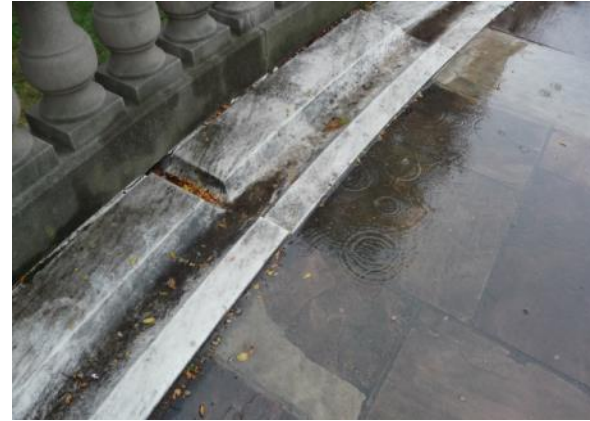
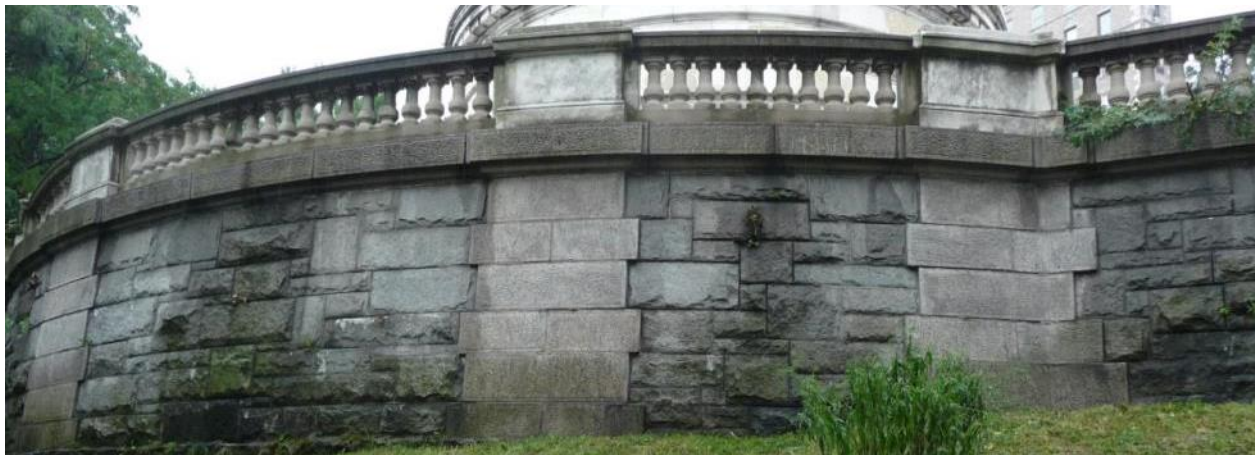
Site Drainage

- ~ Findings: Failed drainage system causing collateral deterioration
- ~ Recommendations: Replace complete paving and drainage system

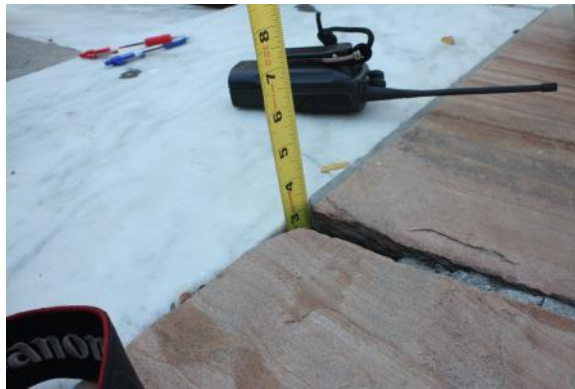
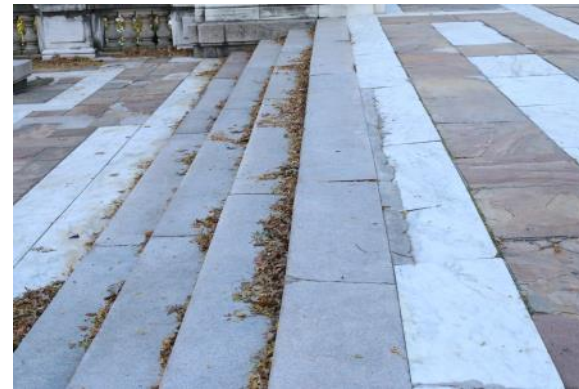
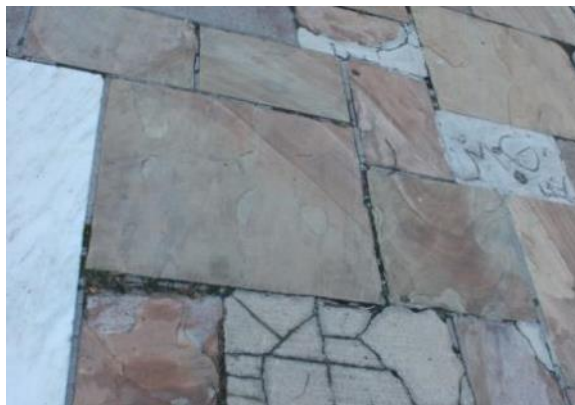
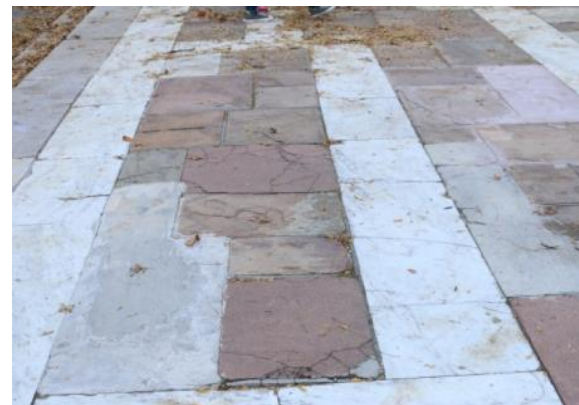
Marble and Sandstone Paving

- ~ Findings: Heaving and displacement, severe sandstone deterioration
- ~ Recommendations: Remove and reset marble; replace sandstone with granite or marble pavers; replace substrate and introduce new drainage

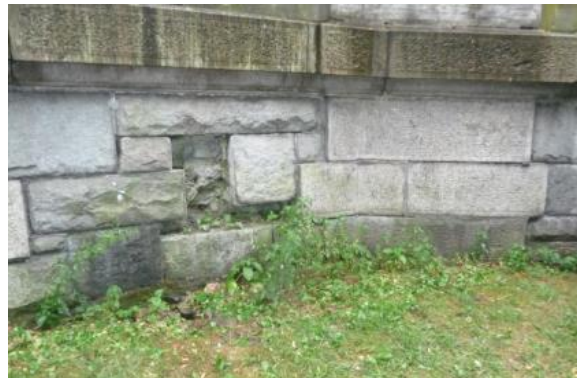
Granite Veneer Foundation Stones

- ~ Findings: 100% deteriorated mortar joints, plant growth, displacement, and selective failure
- ~ Recommendations: Remove plants, grout injection, 100% repointing, selective rebuild of missing and severely displaced units; cordon off areas of loose stone at northern retaining wall

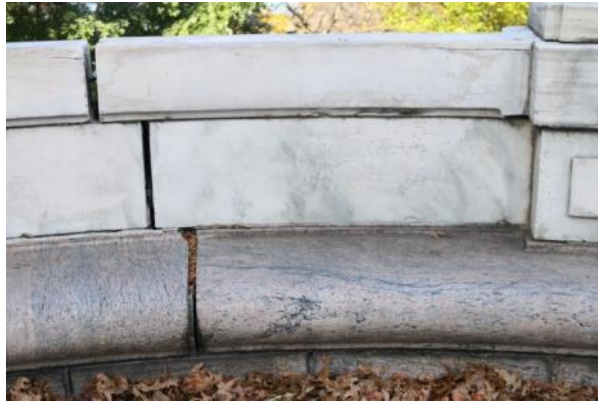
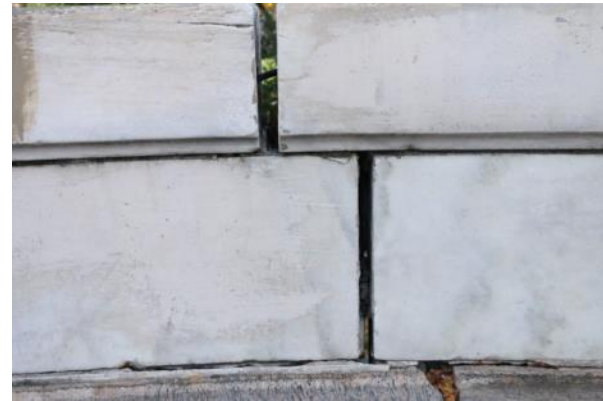
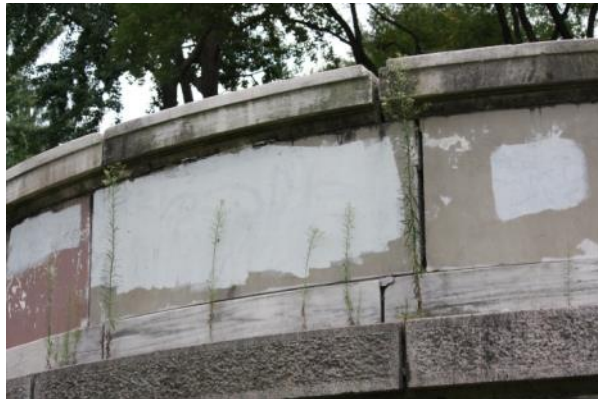
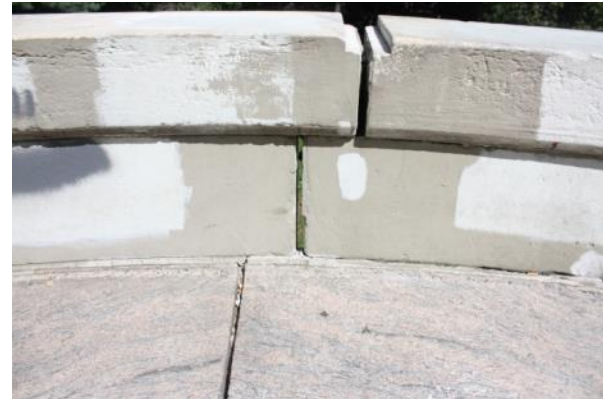
Semi-Circular Marble Bench Backs at Belvedere and Flagpole Platform

- ~ Findings: Severe displacement and outward bowing of stonework
- ~ Recommendations: Remove and reset marble units above granite benches

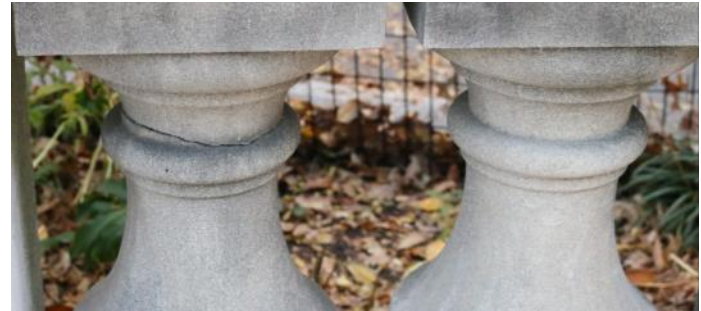
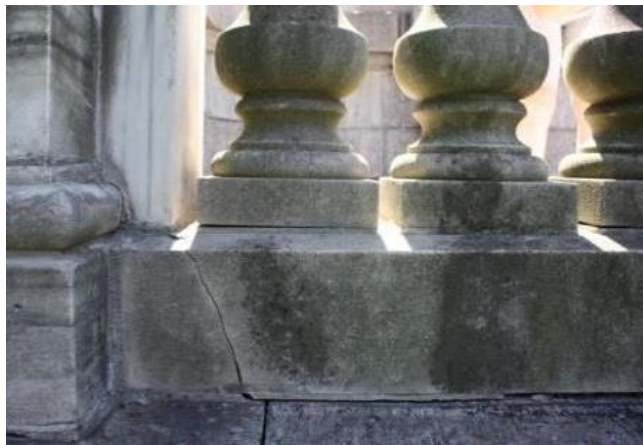
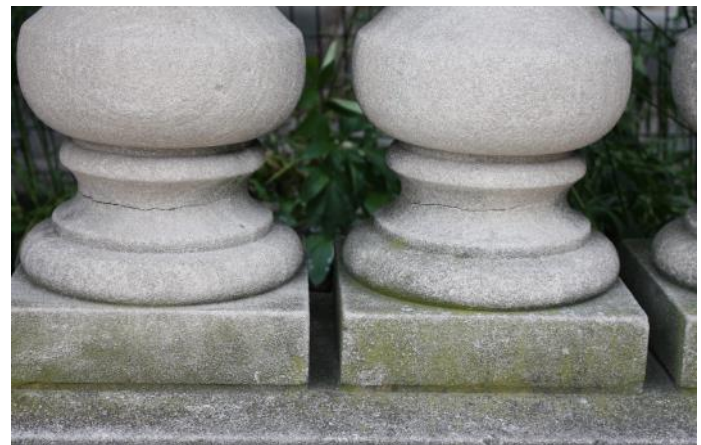
Limestone Balustrades

- ~ Findings: Plaza settlement cracks at plinth and full-depth baluster cracks
- ~ Recommendations: Remove, repair, reset

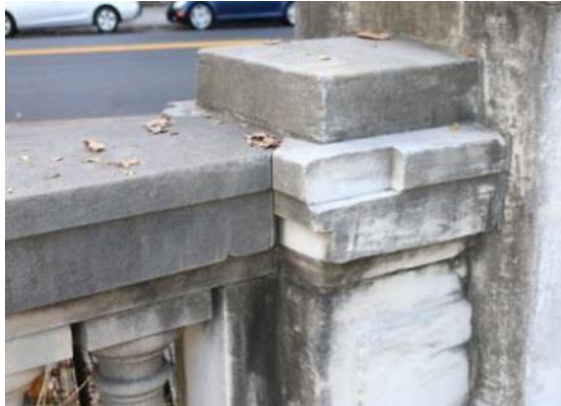
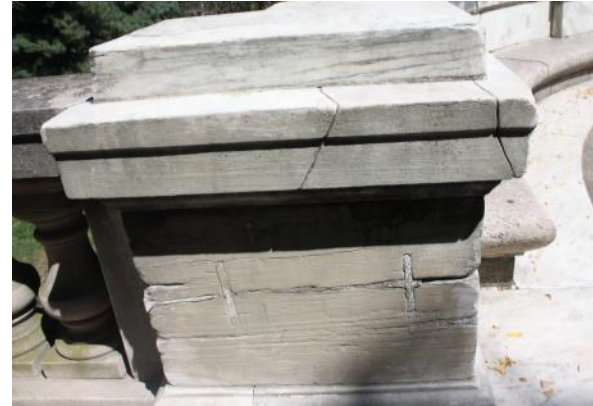
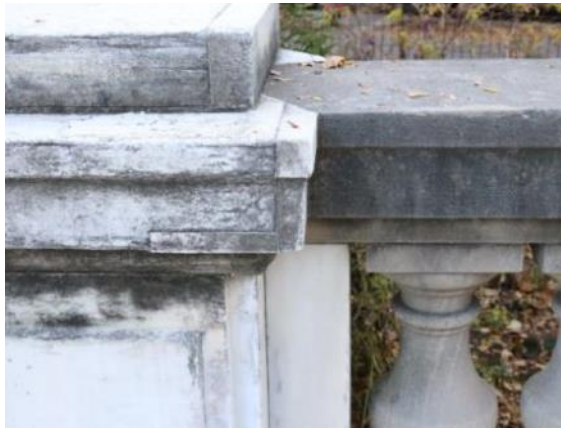
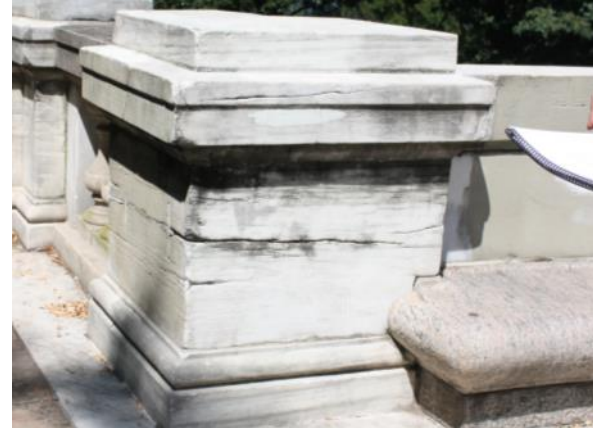
Marble Piers

- ~ Findings: Missing and failed Dutchman repairs, erosion fissures and cracks
- ~ Recommendations: Install new marble Dutchman with surgical pins, fill with hydraulic lime patch filler, pin other cracks

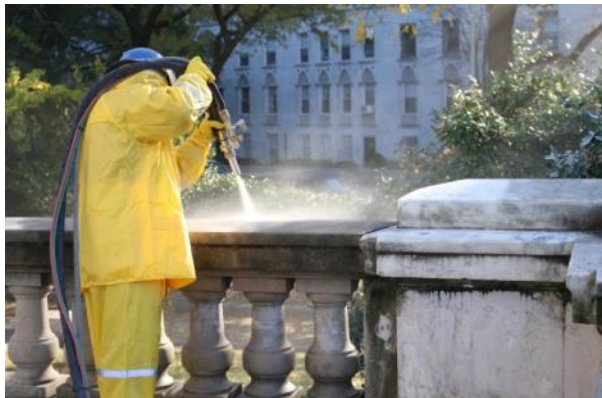
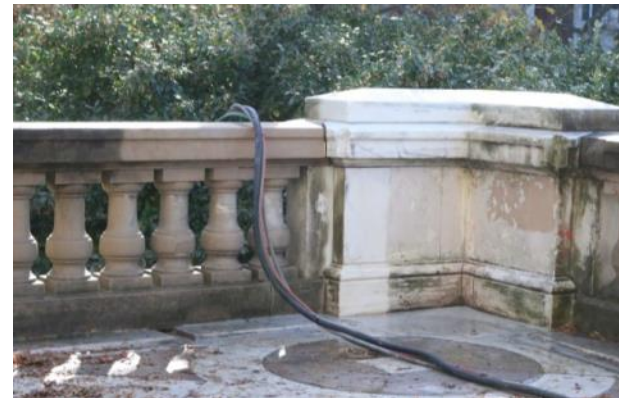
Marble and Limestone Surfaces (Monument and Balustrades)

- ~ Findings: Graffiti and soiling
- ~ Recommendations: Peel Away 7 and Rotec Vortex Micro-abrasion

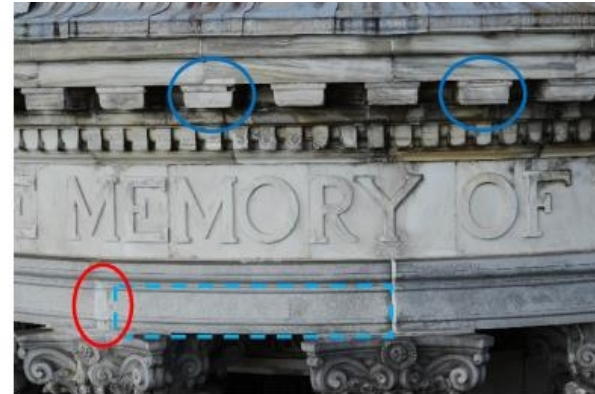
Figure 23: Image showing the condition around the stone with cooler thermal response

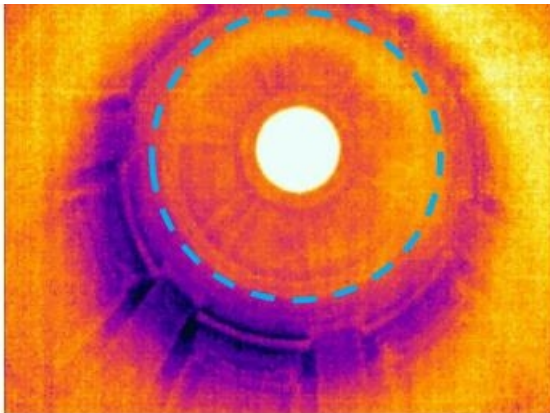
Figure 27: Infrared Image of the lower dome before rain event

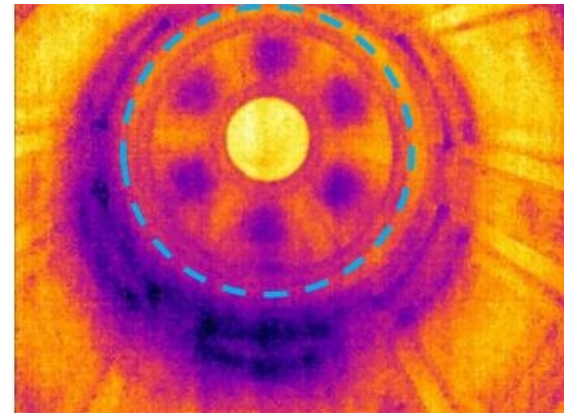
Figure 28: Infrared Image of the lower dome after rain event
