Soldiers' & Sailors' Memorial: Conditions Survey & Restoration Treatment Study

Final Presentation – Community Board

22 February 2017

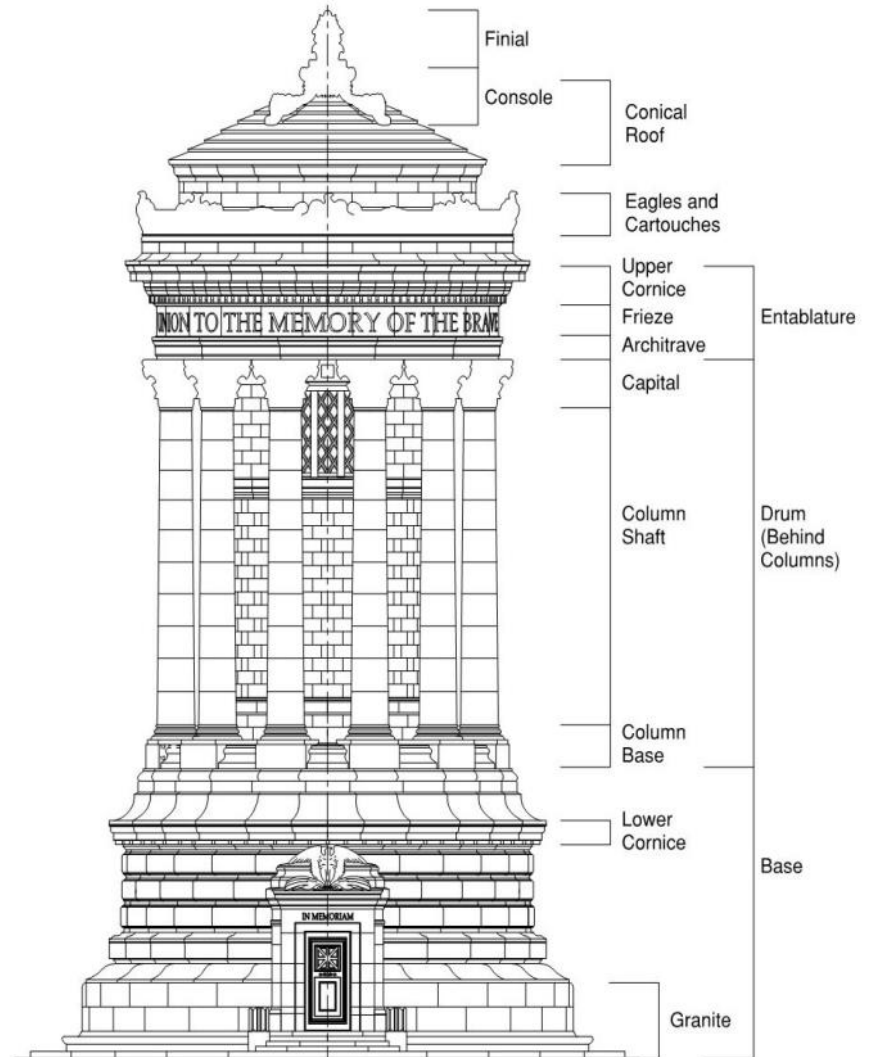
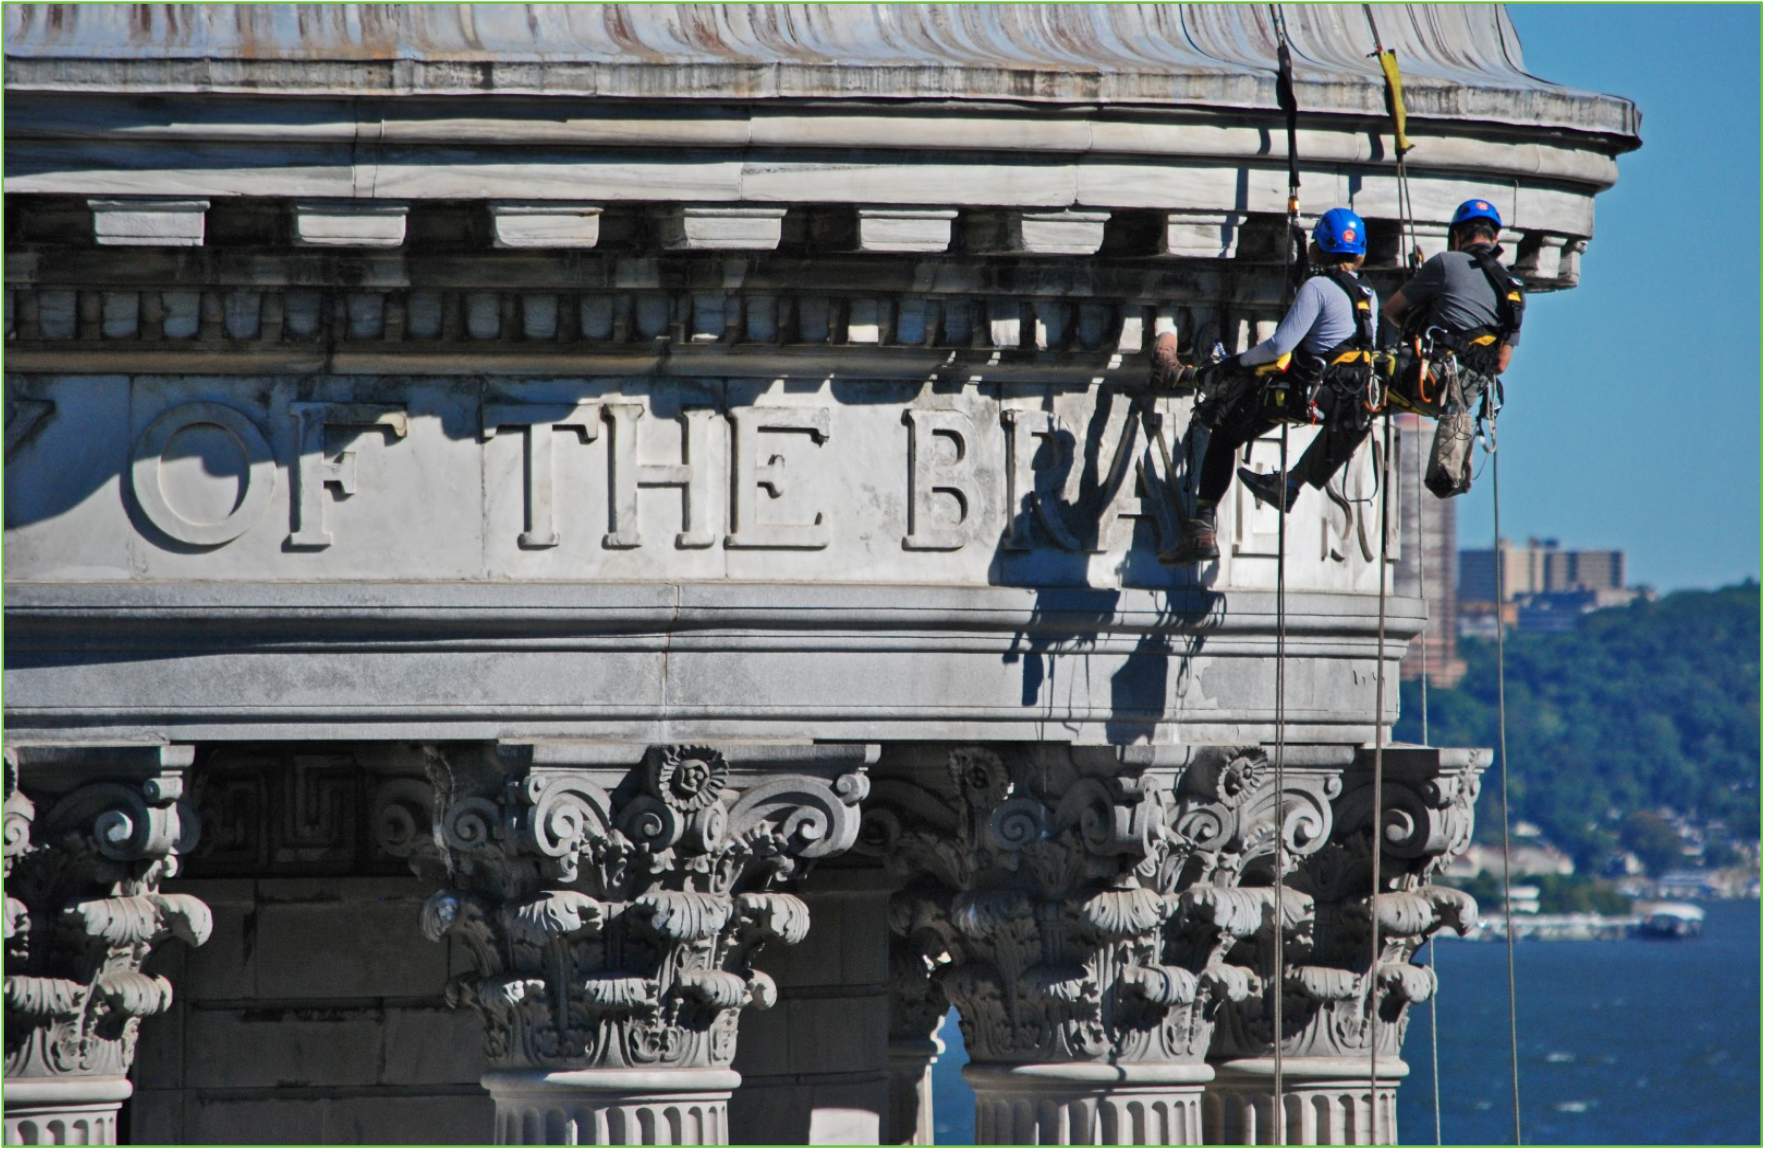
Monument Exterior

~ Findings: Cracks

~ Recommendations: Crack filler, pinning, Dutchman repairs

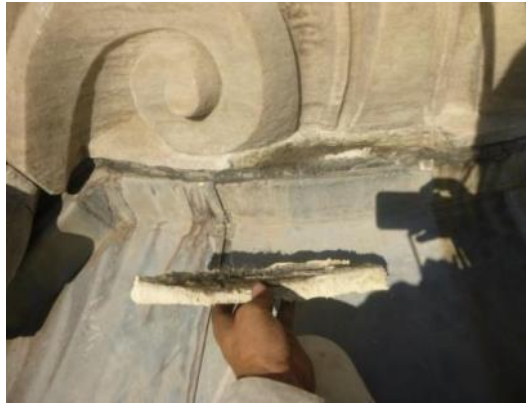
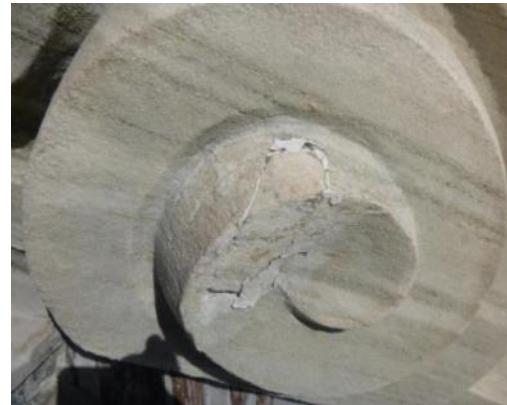
Finial and Consoles

~ Finding: Spalls, failed patches, and fissures

~ Recommendation: Dutchman, patch and crack filler

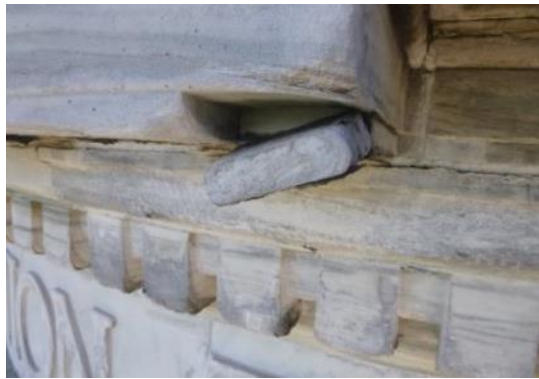
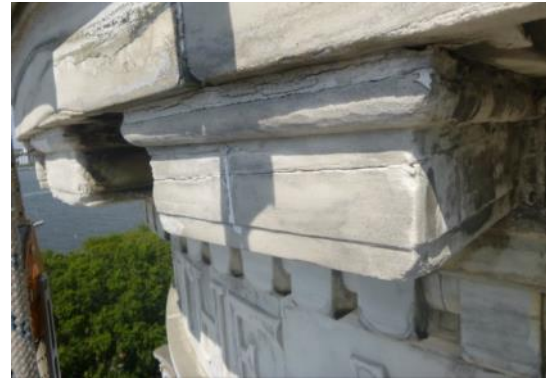
Upper and Lower Modillions

~ Findings: Failed Dutchman, crack repairs and ACM in sealant, typ., fissures, and spalls

~ Recommendations: New Dutchman, consolidation, sealant abatement

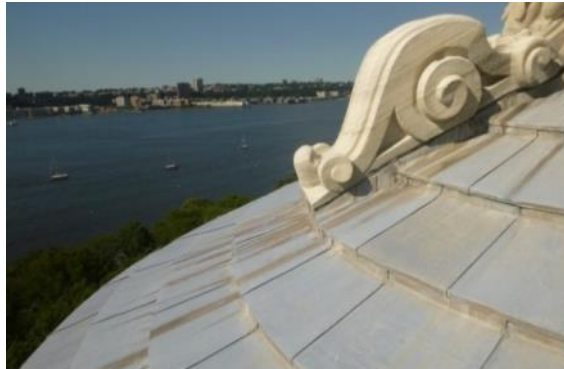
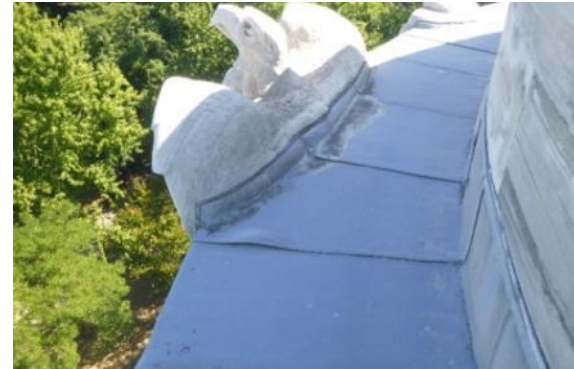
Monument Exterior – Sheet Metal Roofing

~ Findings: Main Roof, Gutter Infill, Cornice – repairable

Base of Drum – excessive tears and holes

~ Recommendations: Repair Main Roof, Gutter Infill, Cornice;

Replace lower drum roof with liquid-applied membrane

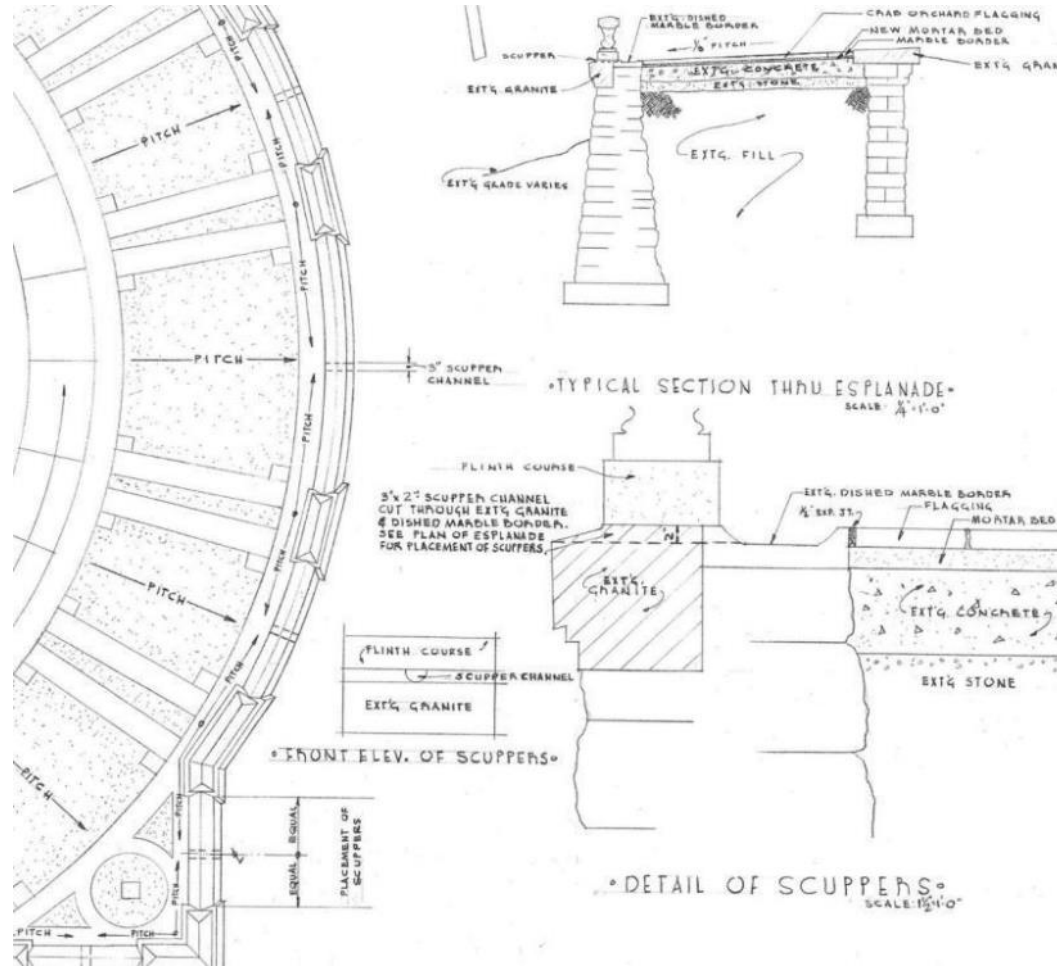
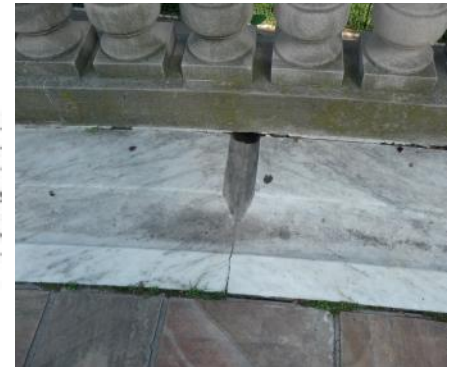
Site Drainage

- ~ Findings: Failed drainage system causing collateral deterioration
- ~ Recommendations: Replace complete paving and drainage system

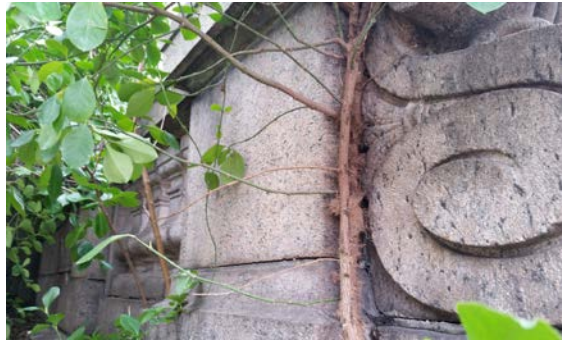
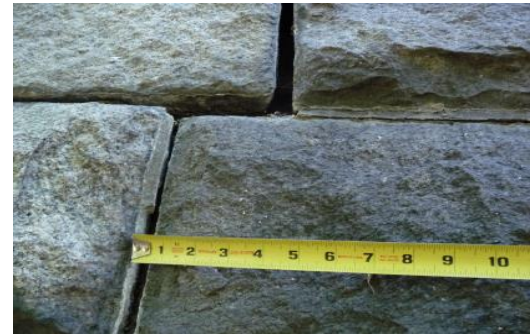
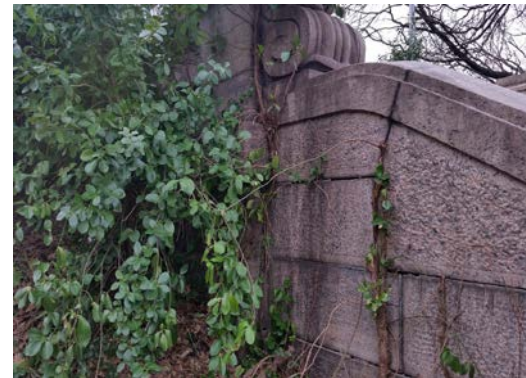
Granite Veneer Foundation Stones

- ~ Findings: 100% deteriorated mortar joints, plant growth, displacement, and selective failure
- ~ Recommendations: Remove plants, grout injection, 100% repointing, selective rebuild of missing and severely displaced units; cordon off areas of loose stone at northern retaining wall

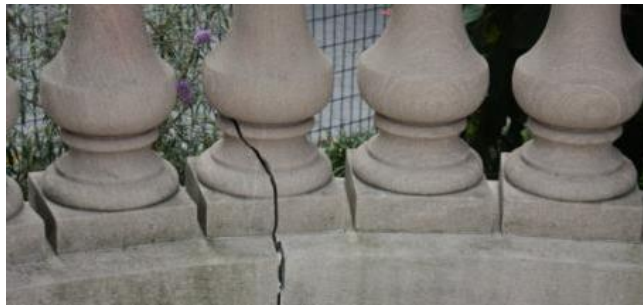
Limestone Balustrades

- ~ Findings: Plaza settlement cracks at plinth and full-depth baluster cracks
- ~ Recommendations: Remove, repair, reset

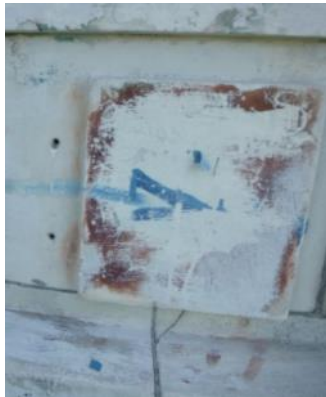
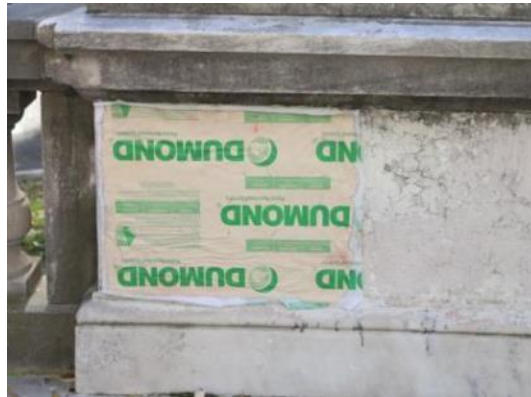
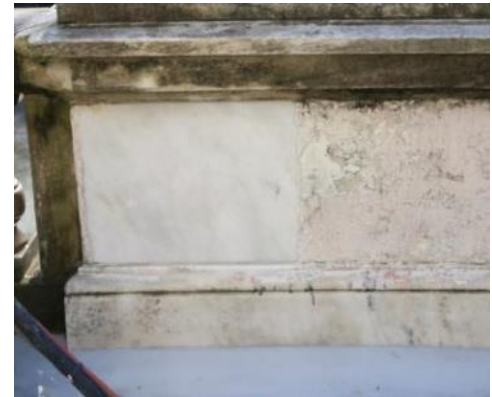
Marble and Limestone Surfaces (Monument and Balustrades)

- ~ Findings: Graffiti and soiling
- ~ Recommendations: Peel Away 7 and Rotec Vortex Micro-abrasion

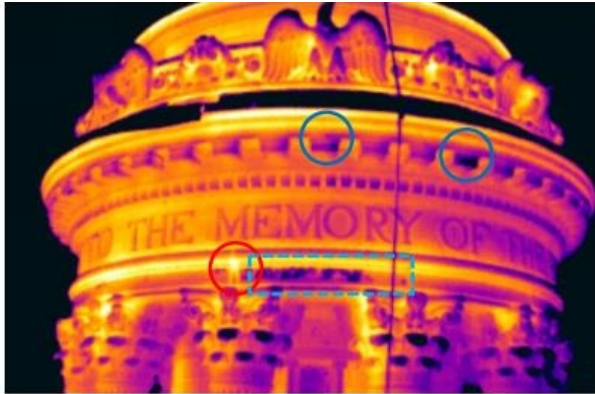
Figure 22: Infrared Image of the architrave at the front elevation
